Teton Dam Failure Case Study

Summarized from Solava and Delatte, *Lessons from the Failure of the Teton Dam*, Proceedings of the 3rd ASCE Forensics Congress, October 19 - 21, 2003, San Diego, California

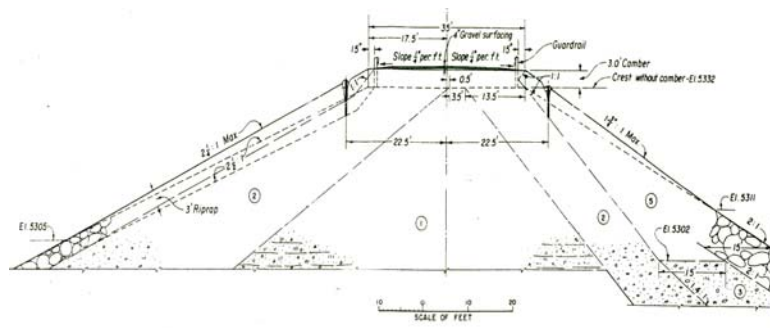
Figure 1b. Dam Construction Details – Cross Section (from Independent, 1976)

The embankment itself consisted of five main zones. Zone 1 was the impervious center core, which formed the water barrier of the dam. Zone 2 overlaid Zone 1 and extended downstream to provide a layer to control seepage through the foundation. Zone 3 was downstream and its main function was to provide structural stability. Zone 4 consisted of the storage areas downstream from the control structure and the temporary enclosures built to permit the work to be done. Finally, Zone 5 was the rockfill in the outer parts of the embankment (Independent Panel, 1976). Some of these features are shown in Figure 1.

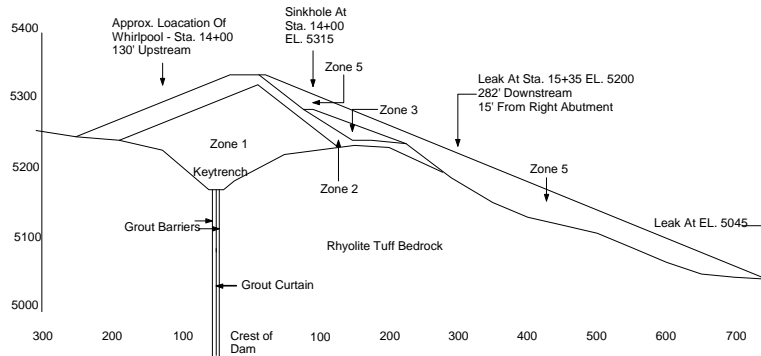
Figure 2. Initial failure indications (from Independent Panel, 1976)

At 11:00 a.m. a whirlpool was observed in the reservoir directly upstream from the dam and four bulldozers were sent to try to push riprap into the sinkhole near the dam crest (Independent Panel, 1976). Two of the bulldozers were swallowed up by the rapidly expanding hole, and the operators were pulled to safety by ropes tied around their waists (Teton Dam Flood @ 2002).

Figure 2 shows a cross section of the dam with the approximate locations of the seepage, the sinkhole, and a whirlpool in the reservoir noted.
