## EFFECTS OF FOREST LAND MANAGEMENT ON EROSION AND REVEGETATION AFTER THE ERUPTION OF MOUNT ST. HELENS

BRIAN D. COLLINS AND THOMAS DUNNE

*Department of Geological Sciences and Quaternary Research Center, University of Washington, Seattle, WA 98195, U.S.A.*

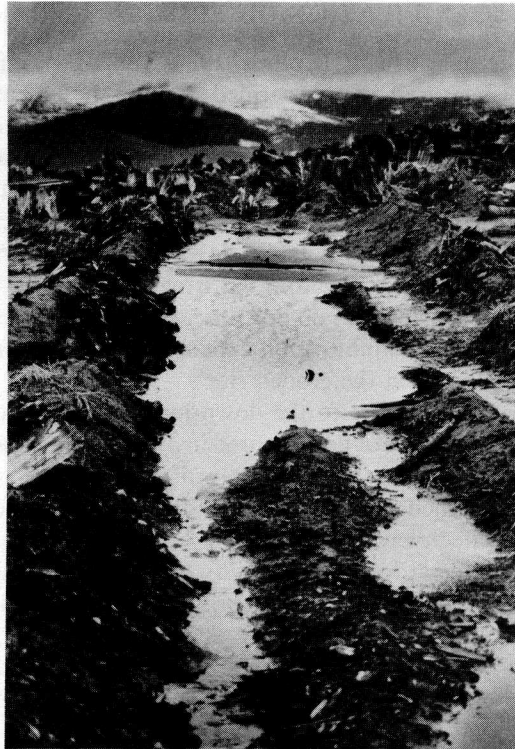
Figure 6. Runoff from adjacent, unscarified slopes or from nearby roads was in some instances diverted onto scarified slopes. The contour trenches created by scarification functioned as effective traps of water and sediment. Photo taken in January 1982 on the Rhino 2 site

The creation of microtopographic barriers to the downslope movement of water and sediment had an additional effect on infiltration that could not be measured in a small-plot experiment. The contour-trenched topography caused the local ponding of water and sediment. Little runoff was generated on the scarified slopes, but where runoff was channelled onto the scarified areas from adjacent, unscarified slopes or from roads, water and sediment were effectively trapped by the contour trenches (Figure 6).

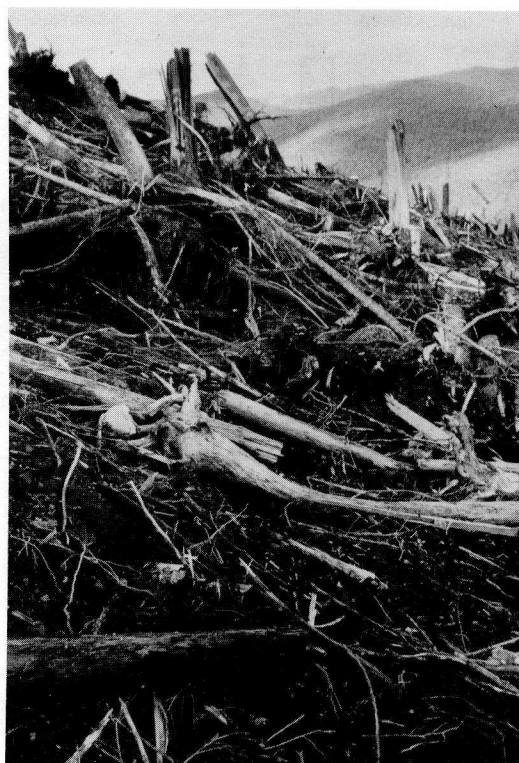
Figure 8. Cable-logging of downed forests created a rough, irregular surface topography formed by organic debris and mixed the tephra layer with soil and organic matter. Photo taken in May 1981 on the Hoffstadt 2 site

Logging of blowdown trees mixed tephra layers, soil, and organic matter, created an irregular and less erodible surface (Figure 8), and resulted in an increase of the infiltration capacity that was similar to the increase resulting from scarification (Table I).
