# Airborne Thermal Infrared Remote Sensing Clakamas River, OR

Survey Date: August 12, 2006  
Report Date: October 15, 2006

# REPORT FOR THERMAL INFRARED REMOTE SENSING CLAKAMAS RIVER, OR

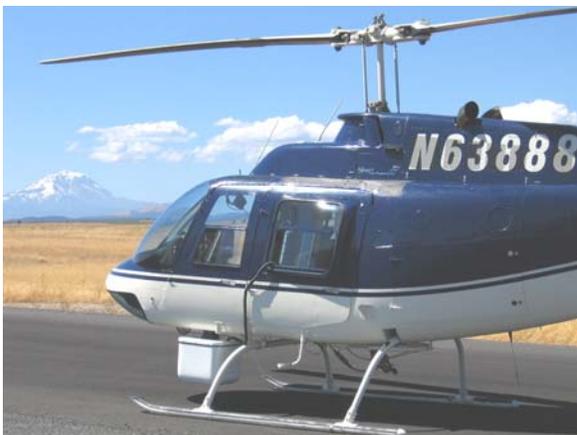
Figure 2 – Bell Jet Ranger equipped with a thermal infrared radiometer and high resolution digital camera. The sensors are contained in a composite fiber enclosure attached to the underside of the helicopter and flown longitudinally along the stream channel.

Instrumentation: Images were collected with a Space Instruments FireMapper 2.0 sensor (8-12 $\mu$ m) mounted on the underside of a Bell Jet Ranger Helicopter (Figure 2). The TIR sensor was co-mounted with a high-resolution true color digital camera (*Nikon D2X w/ 24mm lens, 6.9 mega-pixels*). Both cameras were positioned to look vertically down from the aircraft (nadir).
