Airborne Thermal Infrared Remote Sensing McKenzie River Basin, Oregon

Watershed Sciences, Inc.
257B Madison Avenue
Corvallis, OR 97333

October 30, 2009

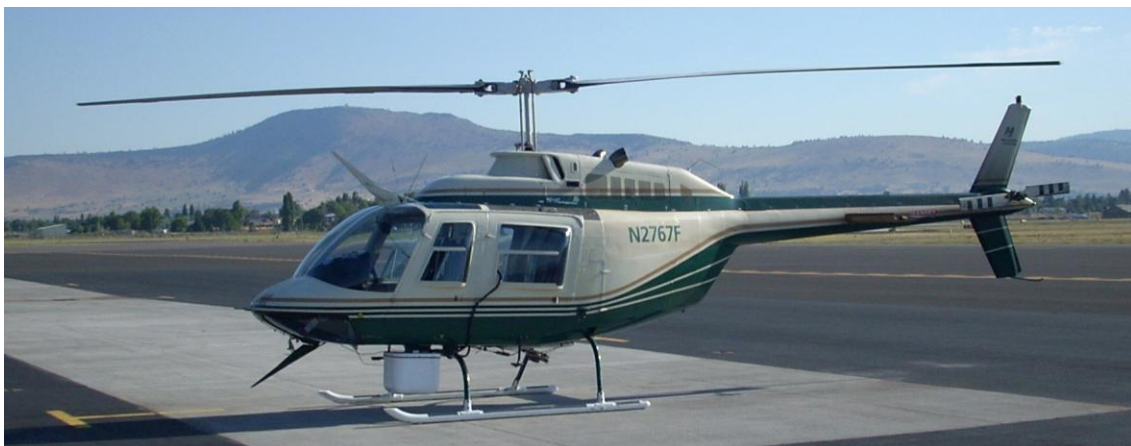
Figure 2 – Bell Jet Ranger equipped with a thermal infrared radiometer and high resolution digital camera. The sensors are contained in a composite fiber enclosure attached to the underside of the helicopter and flown longitudinally along the stream channel.

Instrumentation: Images were collected with a FLIR system's SC6000 sensor (8-9.2 μ m) mounted on the underside of a Bell Jet Ranger Helicopter (*Figure 2*). The SC6000 is a calibrated radiometer with internal non-uniformity correction and drift compensation. General specifications of the thermal infrared sensor are listed in Table 2.

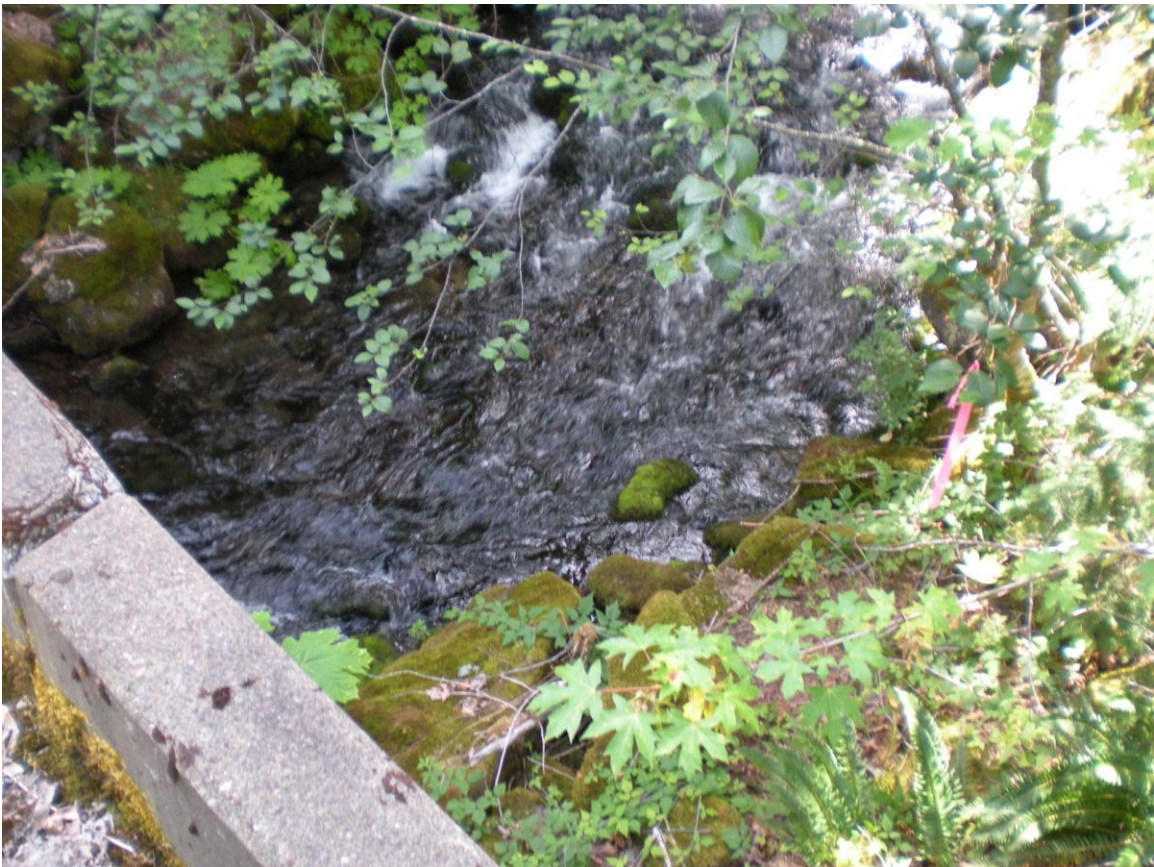
Figure 7 – The photo above shows the location of the HoboPro sensor on Elk Creek. The narrow width of the stream in addition to the heavy vegetation may account for the higher than normal radiant temperatures.

The sensor on Elk Creek fell outside of the target accuracy of $\pm 0.5^{\circ}\text{C}$. At this location the water surface was masked by riparian vegetation in the TIR imagery. The higher radiant temperatures at this location likely resulted due to mixed or hybrid pixels (i.e. water and vegetation or rocks) resulting in higher radiant temperatures. Much of Elk Creek had plant canopy masking the water surface (*Figure 7*). Radiant temperatures derived from these images should show general longitudinal trends, but caution should be used in interpreting localized temperatures in Elk Creek.

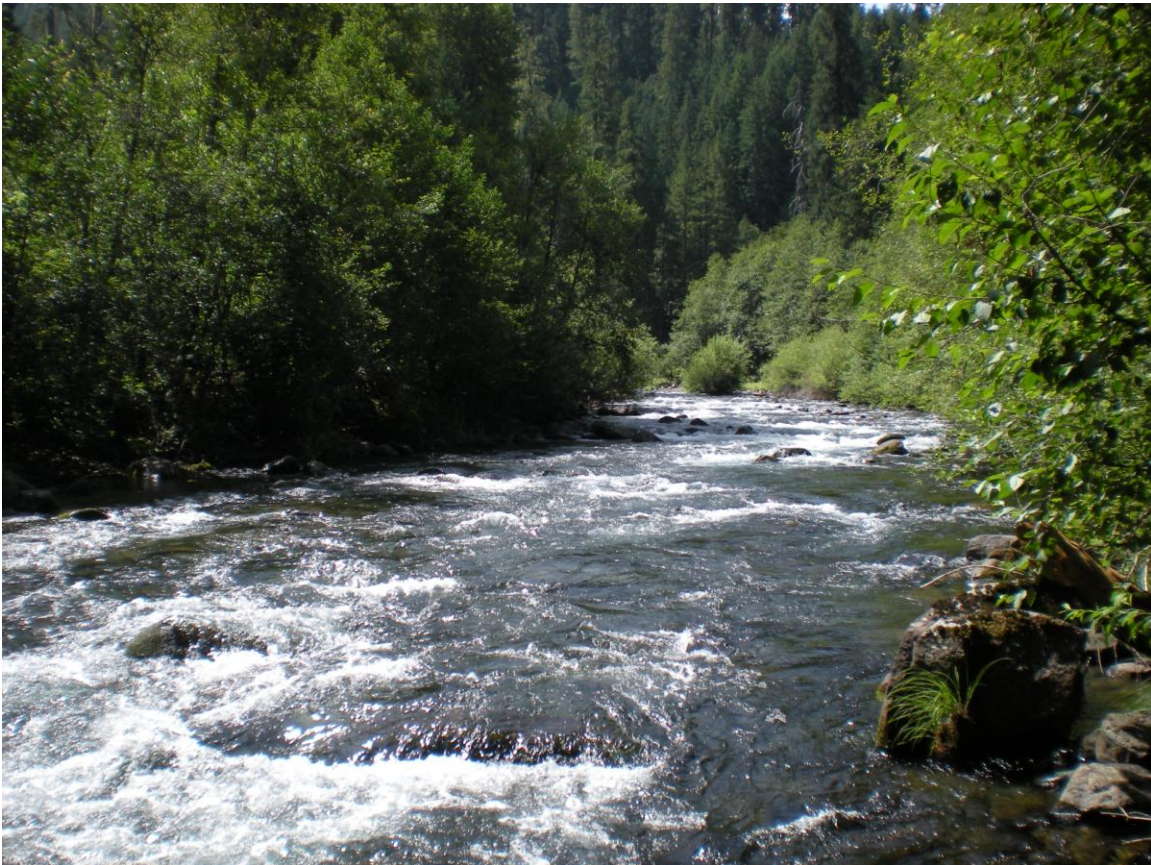
Figure 8 – Ground level digital photo of the South Fork McKenzie River on the day of the TIR survey

Due to the nature of the project, the focus of the survey was to depict the thermal conditions during peak temperatures. Given the warm temperatures on the days of the survey, features such as hot springs may have been ‘washed out’ in comparison to the surrounding terrestrial landscape. The sample images contained in this report are not meant to be comprehensive, but provide examples of river features and interpretations. Figure 8 below provides a ground level photo of the South Fork McKenzie River on the day of the TIR survey.
