**Colorado Cultural Resources Survey Form:
Moraine Park Museum Amphitheater**

Manish Chalana, Design and Planning
University of Colorado

HISTORIC BUILDING NAME(S):
Moraine Amphitheatre

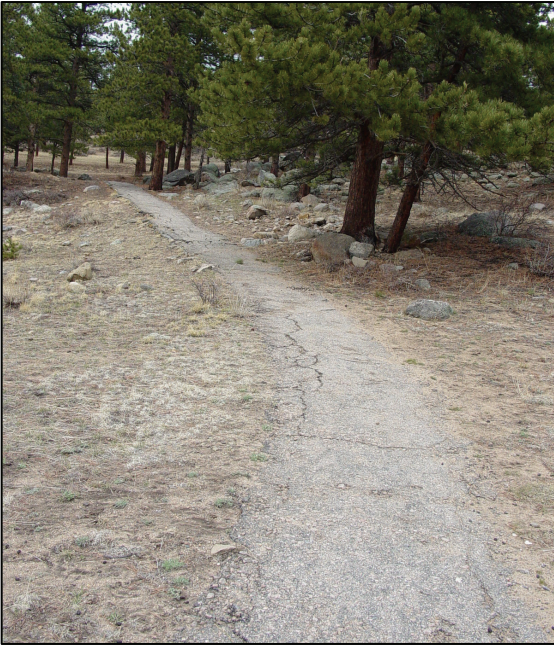
Fig. 2 (left): The asphalt trail from the parking lot to the amphitheatre. Fig. 3 (right): The elaborate drainage design concealed within the slope behind the stage.

to the amphitheatre may have been finished with irregular stones (not confirmed). Two trails (earth-packed and lined with rough stones) coming from the back and front of the Moraine Park Museum converge and meet the asphalt trail close to the edge of the stone steps. Their convergence is marked by a large pine tree surrounded by common chokecherry, with other shrubs and stones scattered in the landscape. From this point the asphalt trail to the amphitheatre is lined by pine trees and gains elevation to arrive at the stage area of the amphitheatre (fig. 2).

The amphitheatre is accessed from the parking lot of the Moraine Park Museum by a flight of steps located at the northwest corner. Constructed from rough hewn stone, the sixteen steps have irregular treads measuring 14-16" and rises measuring 3-5". The steps reach an asphalt trail 3-4' wide that heads northwest in the direction of the amphitheatre, gaining gradually in elevation. The asphalt is cracked and appears to have been poured over existing stonework. It is possible that the original trail

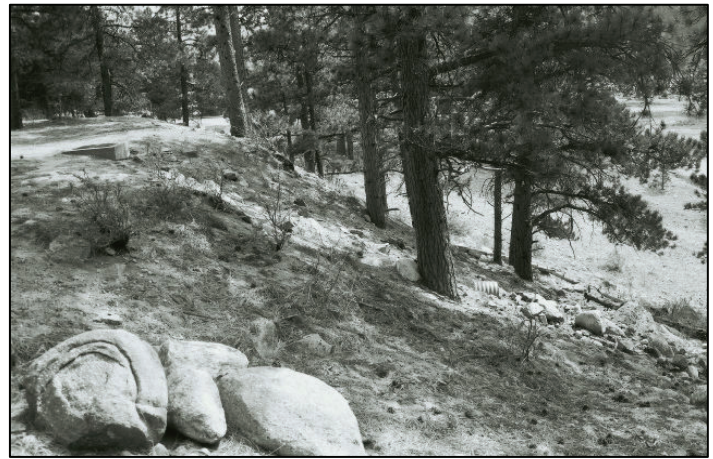
The design of the Moraine Park Amphitheatre maximizes the use of existing site conditions (such as the bowl shape) and natural materials to carefully craft architecture that blends with the setting, enhancing the naturalness of the site. The earth cut from the seating area of the amphitheatre was likely used to create the slope that holds the stage area. At the edge of the slope is a drain that channels stormwater down the slope into another channel defined by a stone lining, before entering an inlet under Bear Lake Road. This drainage pattern exemplifies the elaborate construction techniques used in the creation of the site (fig. 3).

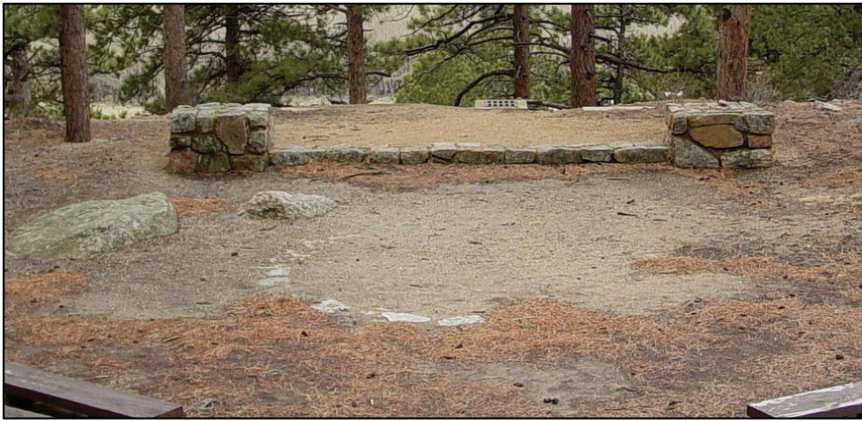
The elliptical stage area is marked by a partial remain of the stage (two of the four corners pieces still remain) and a line of trees forming the curtain wall behind the stage. Partial remains of a traditional campfire—embedded stones that once defined the ring of the circular fire pit—can still be seen in front of the stage wall (fig. 4a). A few large stones remain *in situ*, revealing their smooth surface on the floor of the stage. The wooden picture screen on which the slides were projected no longer remains (fig. 4b).

Fig. 4: (a) The filled-in fire pit. Seen are the remains of the ring of stones around it.

(b) Stage area with the remains of the stage. The trees were carefully used in creating a curtain wall behind the stage.

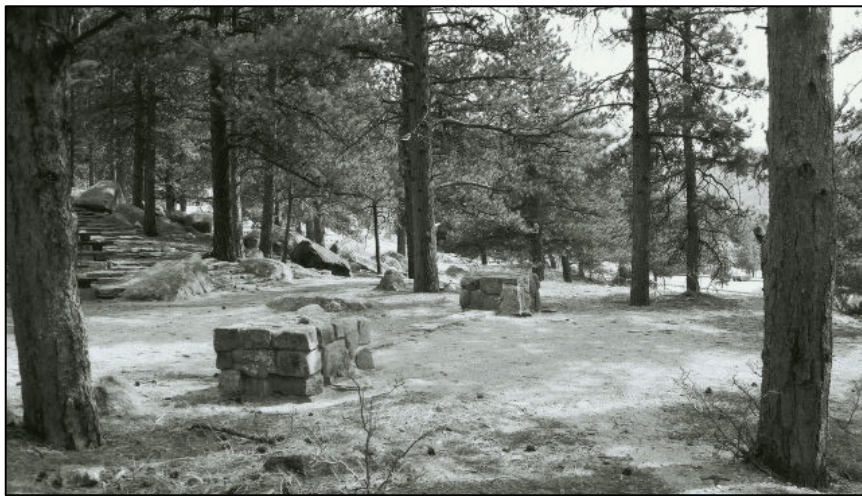
Sixteen aisles and two arcs of seating ascend from the stage area, arranged in an irregular fan shape facing the stage and fire pit. The seats were created by placing a row of somewhat regular stones

Fig. 5: The two rows of seating rise from the stage.

some 10" high. Timber wedges (11" x 4") lie on this stone wall about 4-5' apart, with milled lumber in rectangular planks (2 1/4" x 11" x 4-6") nailed to the wedges. The joinery between the planks as well as the wedges use large unfinished nails. The planks are painted with NPS's signature brown paint. The seating between rows 10 and 13 in the right arc is broken to accommodate an existing tree in a rectangular planting bed and probably also the now-absent projection booth but no evidence substantiates this conjecture (fig. 5). The seats are accessed from three main circulation paths with stone steps. The one in the center is the most regular, about 4' wide. Those on the sides hug closely to the natural slope. Large stones and trees surround the northern corner of the seating area (three trees have been cut down to their stumps for unknown reasons). The circulation path of the south side is defined by a line of trees. Cement mortar was used at some point to stabilize the rocks holding the rectangular seating planks. The lighting fixtures under the seating are defunct.

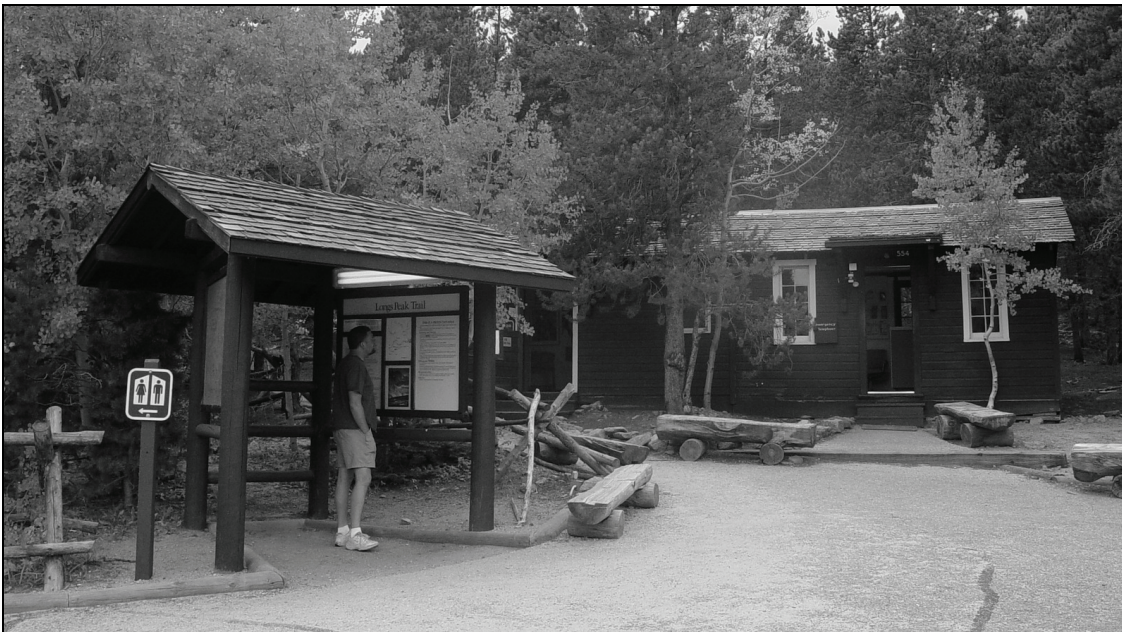
Fig. 7: Longs Peak Trailhead area in Rocky Mountain National Park exhibiting the NPS Rustic Style.

The design of the amphitheatre is grounded in the “naturalistic” style of construction to which NPS required all new designs in the early twentieth century to adhere. Much of the credit for formulating this rustic style goes to Stephen Mather and Horace Albright, the founding fathers of NPS. The style draws primarily from the romantic and the idealistic tenets of nineteenth century designers Andrew Jackson Downing and Frederick Law Olmsted. This “NPS Rustic” style (which some call “parkitecture”) effectively maintained the overall wilderness character of the landscapes and remained *de rigueur* until the 1960s, when it was interrupted for about a decade by the “Mission 66” program. The basic tenets of naturalistic design were straightforward—that architecture would play a subordinate role to nature, the massing of the structure would respond to the terrain, and the design would hide and blend with the naturalness of the setting. Although NPS standardized the design of new buildings in terms of floor plan and elevations, they did not standardize the materials and techniques of construction. Instead, the use of native material available in the vicinity of the site was encouraged, making stone and timber the materials of choice for most parks, including Rocky Mountain. With regard to the techniques of construction, nature again was expected to provide clues, along with the region’s vernacular traditions. Suitable prototypes used natural finishes and handcrafted details emphasizing irregular lines and rough textures, mimicking pioneer traditions of construction (fig. 7).

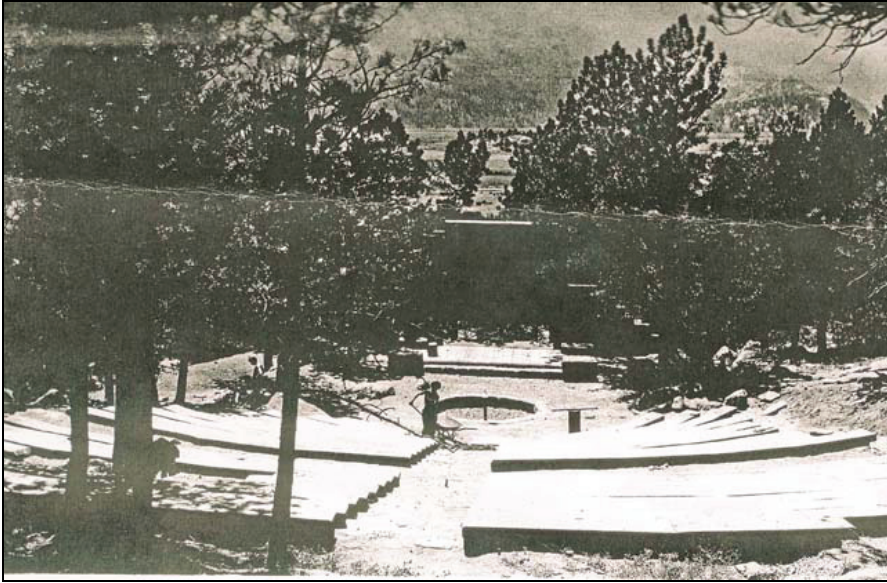
Fig. 8: CCC recruits working on the construction of the amphitheatre. The fire pit in front of the stage can be seen clearly in this old picture.

In Rocky Mountain National Park, as in other national parks and forests, recruits from the New Deal-era Civilian Conservation Corps (CCC) helped out with a variety of tasks relating to construction (road, trail, campground and new building construction) and conservation (maintenance, demolition, improvement, vegetation management). Their legacy remains visible in the park, including the Moraine Park amphitheatre site, but is gradually fading (fig. 8).

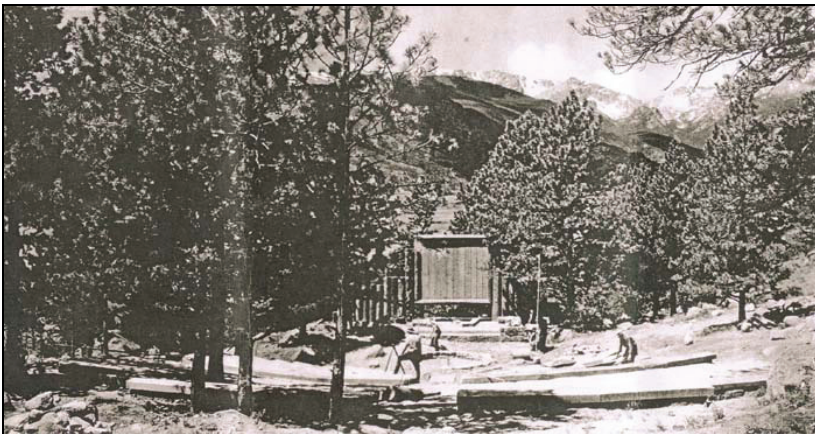
The *Estes Park Trail*—a local newspaper—published a list of the weekly “Program of Free Government Services” offered during the summer high season, including the offerings at the Amphitheatre. The latter included programs as diverse as “Winter Scenes in Colored Movies” (July 28, 1939) and “The Red Man in the Rockies” (July 1, 1938). The success of the Amphitheatre can be seen from an article in the newspaper from April 22, 1938: “Of importance to the naturalist program for the Park visitors was the construction of an amphitheatre, seating 390 persons, near the Moraine Park Museum. Complete in every respect, it is equipped with a large moving picture screen, stage, lighting, projection booth, a fire pit for the comfort and comfortable wooden seats arranged in a semi circle on a slope to assure visibility for all visitors” (fig. 9a).

Fig. 9: (a) The wooden screen of the amphitheatre no longer remains; (b) sunrise religious service being held at the Moraine Park Amphitheatre.

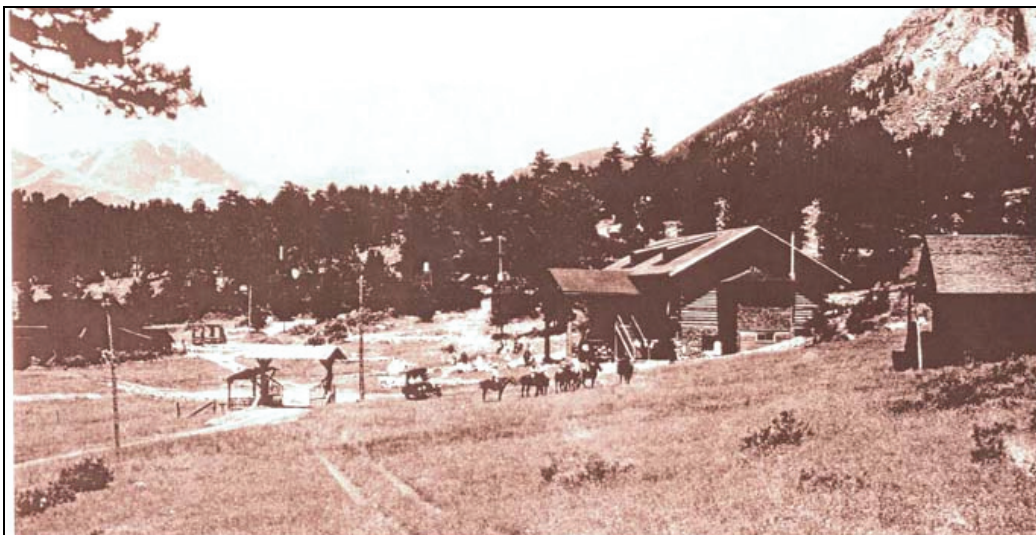
Fig. 10: The site of the Moraine Lodge in 1924

Prior to acquisition by the National Park Service, the site of today's Moraine Park Museum and Amphitheatre contained a resort comprising a recreational building/lodge and a cluster of cabins and other structures (roughly 40 structures total). This resort served as a social hub for the elite residents of the area, especially during the summer season (fig. 10). The resort was open to the public on July 19, 1923 by Ms. M. Imogene Green, who had acquired the land twenty-five years previously from the original homesteader, J. Pringle. That day's *Estes Park Trail* reported: "[t]he new building, just inside the gate to the Lodge grounds, contains the business offices and a nice tea room on the ground floor and the hall occupies the entire second floor." The National Park Service purchased the site from Mrs. McPherson (formerly Miss Green) later in 1931 and razed the existing buildings on the property with the exception of the Assembly Hall.

The condition of the site prior to the rehabilitation can be gauged from the entry in the Superintendents' Monthly Report from October 1933, which noted that "[t]wenty-seven have been razed, the earth regraded to its original slope and some planting done." The remaining building was remodeled in 1936 to become the Moraine Park Museum. Amphitheatre construction started around the same time at an adjacent site. The newly rehabilitated lodge was linked to the amphitheatre by a trail and the two functioned as an important joint interpretative site in the park. The rehabilitation as well as the new construction was carried out by the CCC. The opening of the museum was delayed until the summer of 1937 by the completion of the amphitheatre and the parking lot. The date at which the use of the amphitheatre became discontinued for regular evening programs is unclear; however, it is still used for environmental education and interpretative programs and private functions such as weddings.
