Chimney Damage in the Greater Seattle Area from the Nisqually Earthquake of 28 February 2001

by Derek B. Booth, Ray E. Wells, and Robert W. Givler

Abstract Unreinforced brick chimneys in the greater Seattle area were damaged repeatedly in the Benioff zone earthquakes of 1949, 1965, and 2001. A survey of visible chimney damage after the 28 February 2001 Nisqually earthquake evaluated approximately 60,000 chimneys through block-by-block coverage of about 50 km², identifying a total of 1556 damaged chimneys. Chimney damage was strongly clustered in certain areas, in particular in the neighborhood of West Seattle where prior damage was also noted and evaluated after the 1965 earthquake. Our results showed that damage produced by the 2001 earthquake did not obviously correspond to distance from the earthquake epicenter, soft soils, topography, or slope orientation. Chimney damage correlates well to instrumented strong-motion measurements and compiled resident-reported ground-shaking intensities, but it offers much finer spatial resolution than these other data sources. In general, most areas of greatest chimney damage coincide with best estimated locations of strands of the Seattle fa

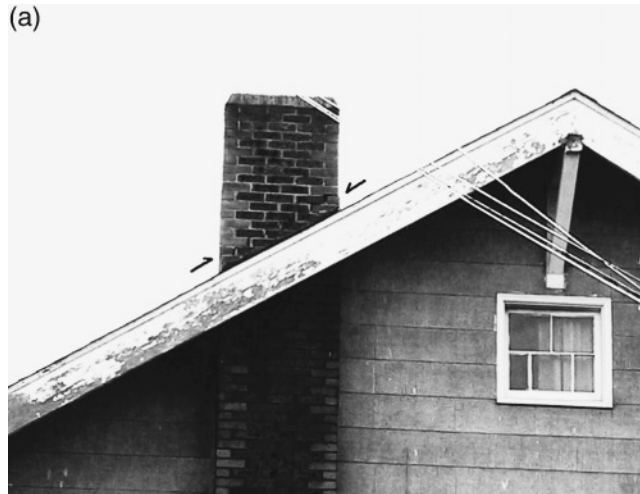
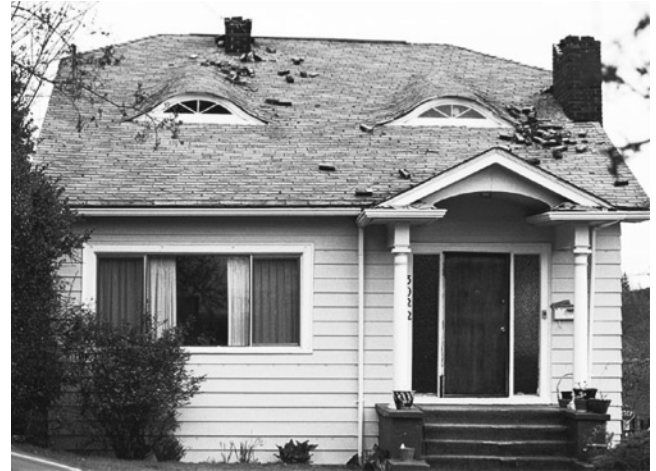
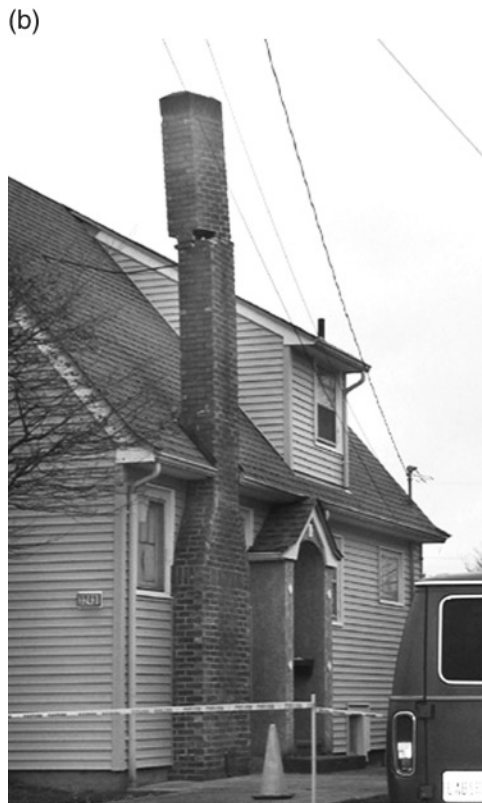
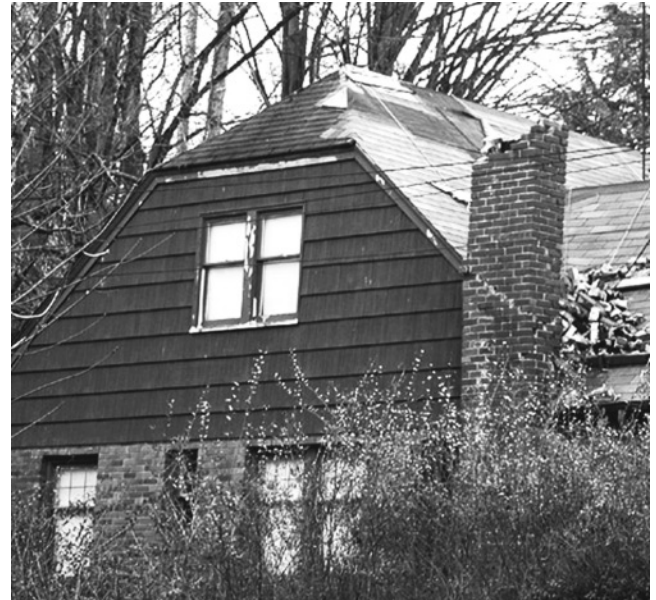
1. Small cracks: cracks or displacements <2 cm, along the mortar joints or in separation from the house; chimney cap or one to two bricks from top course dislodged (Fig. 4a).
2. Large cracks/partial collapse: crack openings >2 cm cut-

ting through the entire chimney; may involve significant rotation/translation of upper part; also includes partial collapse, with a majority of the chimney intact above the roofline (Fig. 4b).

3. Chimney destroyed above roofline: may also involve entire chimney, commonly with damage to adjacent houses (Fig. 4c).

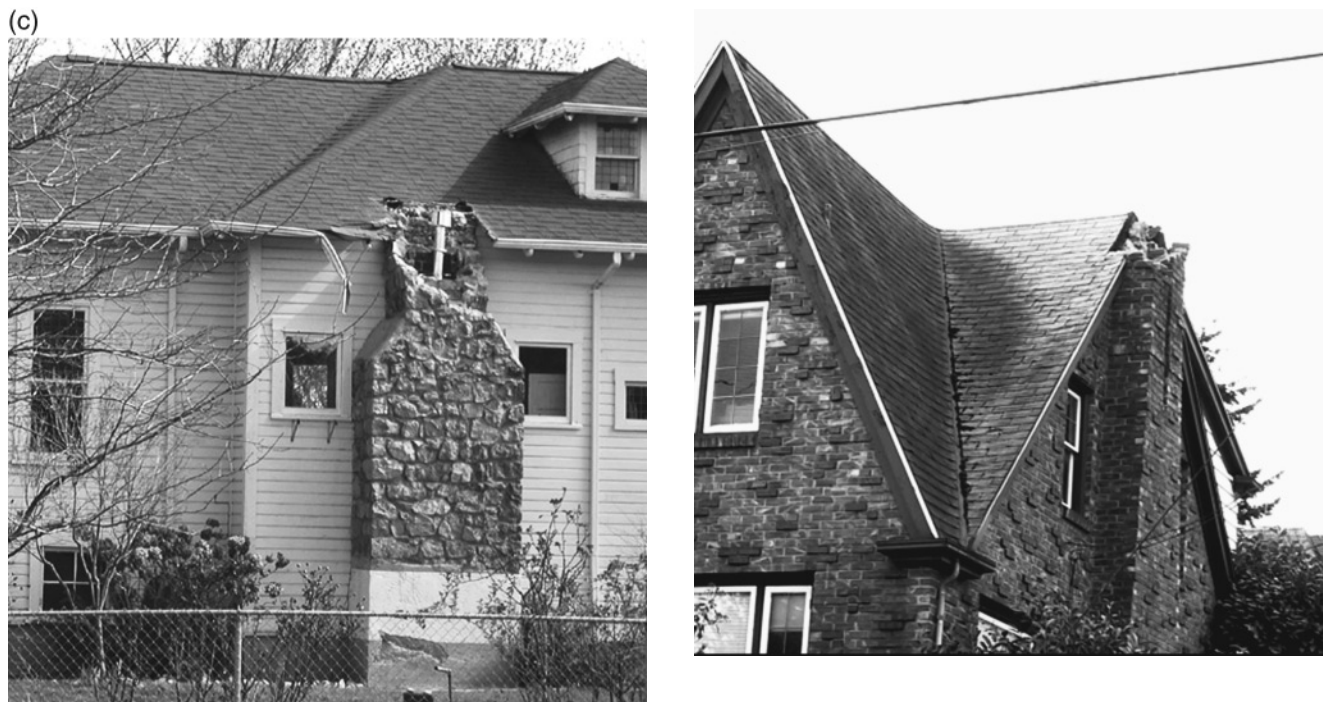
Figure 4. (a) Examples of class 1 chimney damage (the right-hand image also shows a class 2 damaged chimney on the right side of the house). (b) Examples of class 2 chimney damage. (c) Examples of class 3 chimney damage.

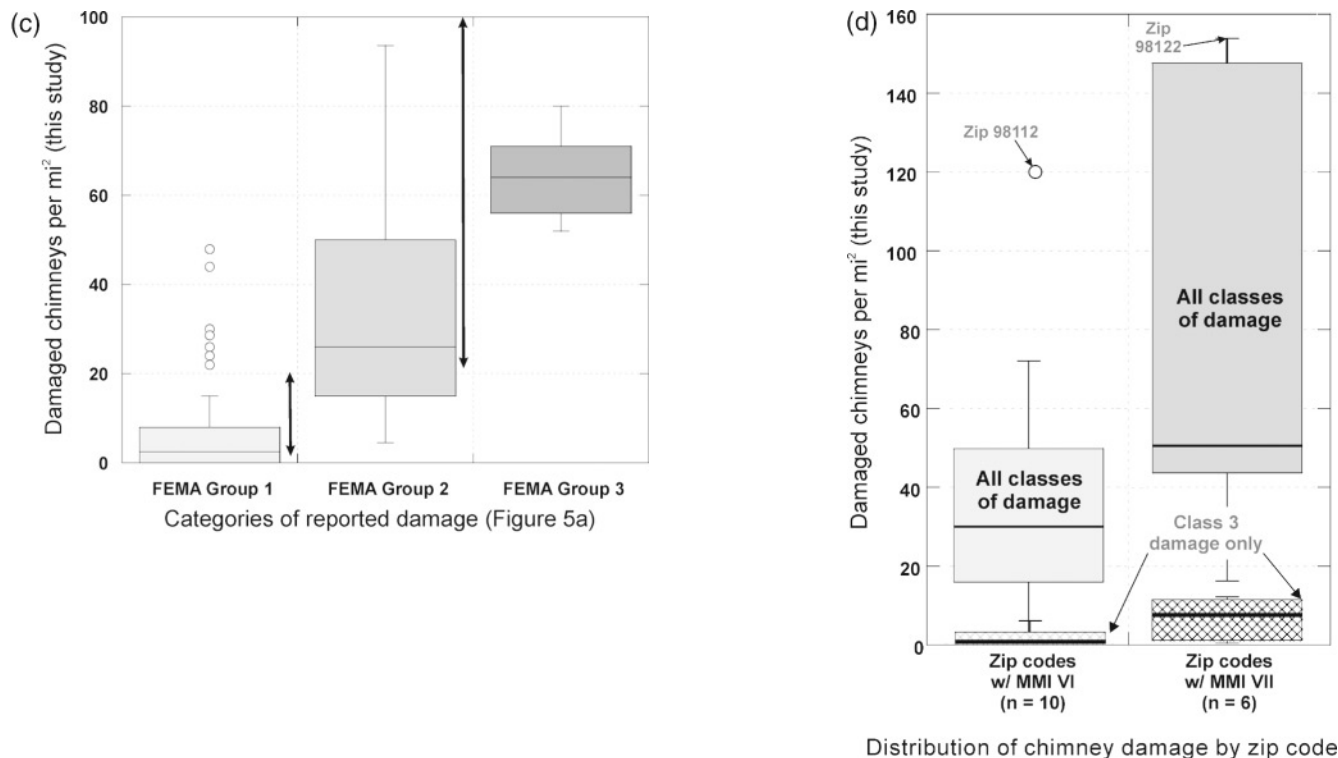
Figure 5. (a) Full survey area and distribution of damaged chimneys. Location of the mapped strands of the Seattle fault from Blakely *et al.* (2002). Shaded squares are 1.6 km (1 mile) on a side and represent the aggregated tally of claims for damaged chimneys made to FEMA as a result of the Nisqually earthquake (J. Toland, FEMA, written commun., 2003). (b) Chimney damage in the Bremerton (left) and West Seattle (right) areas, displayed as a percentage of housing stock in our survey area (outlined). Each grid cell is 155 m on a side, the average long dimension of a residential block here, with a cell area of 2.4 hectares. The number of houses per grid cell varies by neighborhood owing to modest differences in lot size. Faults (dotted lines) are from Blakely *et al.* (2002). (c) Box plots of the number of damaged chimneys observed in this study, grouped by the one-square-mile FEMA damage areas of Figure 5a and normalized by area surveyed. Top and bottom of each box mark the limits of $\pm 25\%$ of the data; median value is displayed as a line. The lines extending from the top and bottom of each box mark minimum and maximum values of the data set, with statistical outliers displayed as individual points. Heavy vertical arrows show the range of each FEMA damage group: 1–20 reported chimneys per square mile, 21–100, and 101–291 per square mile (outside of graph range). Both data sets show excellent correspondence in spatial trends, with the best correlation for areas low to moderate damage. In areas of severe damage, however, the visual survey significantly underestimates reported damage by factors of 2 to 4. (d) Box plot of damaged chimneys per square mile surveyed, tallied by zip codes and grouped by the zip code's reported Modified Mercalli intensity from the Community Internet Intensity Map (<http://pasadena.wr.usgs.gov/shake/pnw/index.html>). Chimney damage is included here for all zip codes where at least 10% of the area was surveyed; both combined damage classes and class 3 (total chimney collapse) are displayed. Outlier (zip code 98112), in the north part of the Madrona area, has a lower MMI and significantly less chimney damage density than its zip-code neighbor (98122) immediately south (VI vs. VII and 120 vs. 154 damaged chimneys per square mile) but a regionally higher density for its reported intensity that suggests either great spatial variability in ground shaking across the zip code (only one-third of which was surveyed) or a neighborhood of generally weaker chimneys. Box plot representation as for Figure 5c.

In the study area, 1556 damaged chimneys were recorded (Table 2). Their locations are shown in Figure 5a, and the damage as a percentage of the housing stock is shown in Figure 5b. More than half of the area surveyed showed no damage at all; much of the balance had only widely distributed and relatively mild damage (i.e., class 1 and only a few class 2s or 3s). We did not systematically evaluate individual or neighborhood differences in chimney age or quality, although those surely exist; instead, we relied on the sheer numbers of observations to indicate whether damage tended to be uniformly distributed or locally clustered, and we confined most of our observations to neighborhoods of similar housing style and age. Chimney damage was greatest in West Seattle, with other noteworthy zones in the neighborhoods of Madrona, south Green Lake, and Bremerton. The overall patterns of damage are quite similar in spatial distribution to the generalized FEMA results that were subsequently made available to us (Fig. 5c), although greater numbers of damaged chimneys in the FEMA data suggest that significant hidden damage was reported to them by homeowners. We also compared our results with those of the U.S. Geological Survey’s Community Internet Intensity Map (Fig. 5d), which also showed very good overall correspondence.

Several areas display diffuse patterns of chimney-damage intensities that vary from 0% to 10% over a broad area. The most prominent is on Beacon Hill, with a zone extending some 5 km to the south over which the occurrence of damage declines only gradually to low levels. Such a pattern is also repeated farther west, in a region within the Seattle fault zone lying south of the high-intensity zone of West Seattle (Fig. 5a and b).

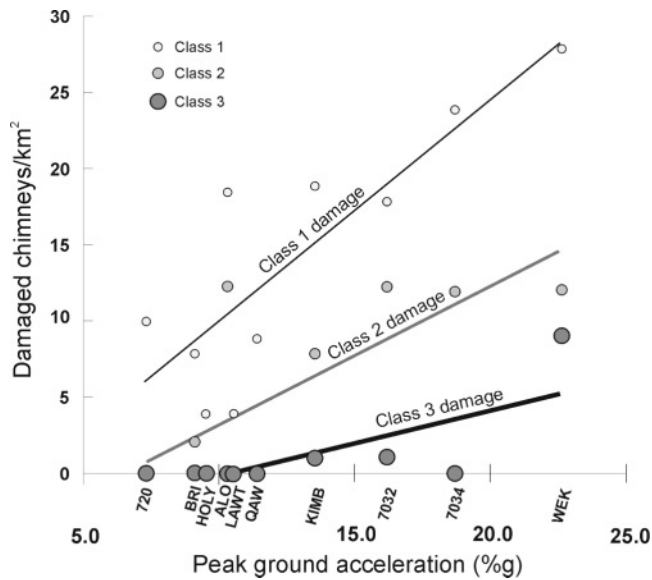
Figure 8. Density of damaged chimneys within a 1-km² square centered on the indicated strong-motion stations (720, Wallingford; BRI and KIMB, Beacon Hill; HOLY, WEK, and 7032, West Seattle; ALO, Capital Hill; LAW, Magnolia; QAW, Queen Anne; 7034, Bremerton). Only those stations that fall within the chimney-surveyed area are included. Chimney damage in the three classes correlates reasonably well with peak ground acceleration, with all r^2 values on the plotted linear-regression best-fit lines >0.74 .
