**RESEARCH ARTICLE**

Opportunities and challenges for restoration of the Merced River through Yosemite Valley, Yosemite National Park, USA

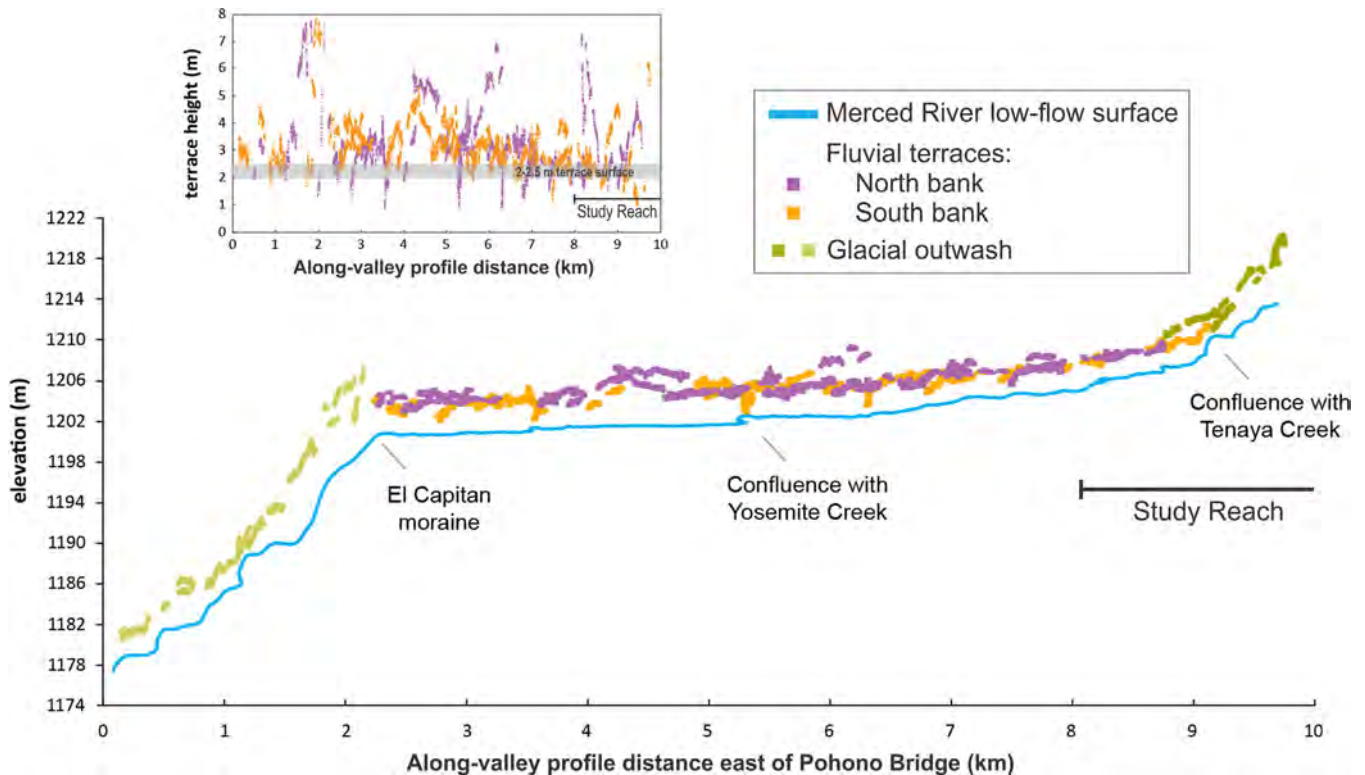
FIGURE 3 Terrace levels adjacent to the Merced River, from Pohono Bridge (left side of the graph) upstream to Clarks Bridge (simplified from Haddon et al., 2017). The x-axis measures distance along the valley axis (not along the river channel itself); the river profile (blue line) approximates the low-water surface when the LiDAR was flown in 2006. Below km 6.5, the “2–2.5 terrace surface” appears to lie at a consistently higher relative elevation, suggesting legacy expression of El Capitan moraine lowering [Color figure can be viewed at wileyonlinelibrary.com]

(unit Qya of Figures 2 and 3), and on which most of the Valley's iconic meadows have developed. This surface is still a zone of active deposition, at least episodically. The oldest date from this sediment is 4.65 ± 0.36 ka (preliminary quartz OSL age; S. Mahan, USGS, pers. comm. 2020) from a sample at a depth of 1.8 m below the surface, along the south bank just downstream of Sentinel Bridge; the youngest sediment dates to the late 19th century (AMS) from a depth of 0.72 m, also along the south bank about 2 km downstream of Sentinel Bridge. This surface has thus been a persistent feature of the fluvial landscape, almost certainly its active floodplain for much of at least the last several thousand years, but more recently removed from regular inundation by virtue of increased channel–terrace relief.

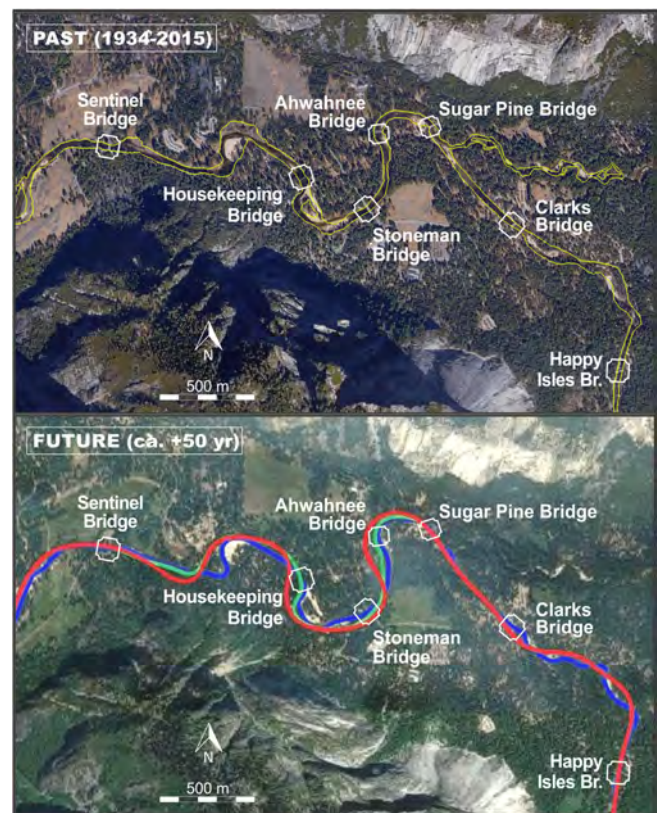
FIGURE 6 Channel migration patterns of the Merced River. Past changes shown by superimposing the 1934 channel position (top panel, yellow outline) on the 2015 Google Earth airphoto. Future changes from the channel centerline in 2016 (bottom panel, blue line) are modelled, with four main areas of existing revetments included (green line) and omitted (red line). The dominant mode of future change is downvalley meander migration where revetments have been removed (i.e., where the red and green lines diverge), with one location of anticipated avulsion between Housekeeping and Sentinel bridges [Color figure can be viewed at wileyonlinelibrary.com]

Only a subset of the stone bridges significantly restrict channel migration processes in the Valley (specifically, Stoneman, Ahwahnee, and Housekeeping bridges; Figure 6). Although Milestone (1978) identified Clarks, Sugar Pine, Stoneman, and Sentinel bridges as having the greatest effect on channel narrowing (all with >40% width reduction over upstream channel dimensions), of this group only Stoneman Bridge also shows a modelled measurable influence on future migration. Conversely, Ahwahnee and Housekeeping bridges are most

influential in restraining channel migration but have imposed width reductions of only 26 and 19%, respectively.

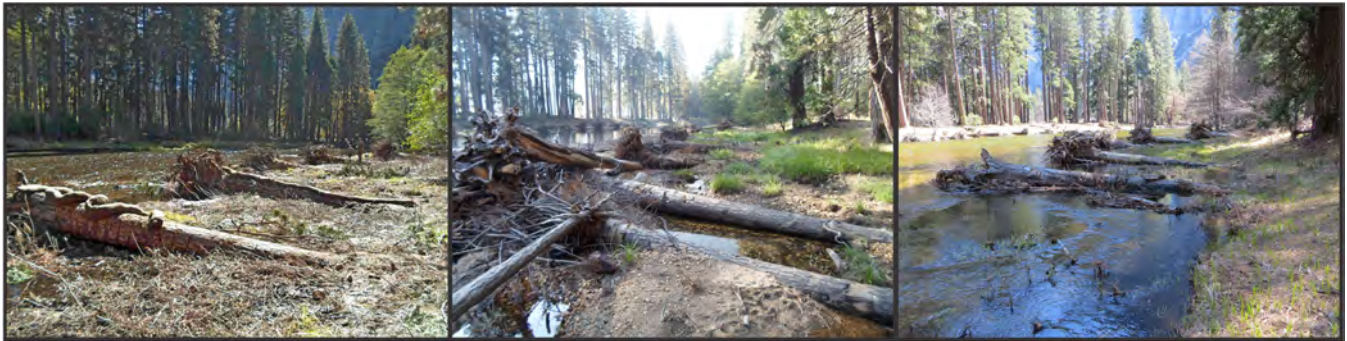
FIGURE 8 Photographs taken over a three-year period of the channel-narrowing and riparian-restoration project constructed about 200 m downstream of Ahwahnee Bridge along the right bank of the Merced River. Project consists of logs with root balls placed perpendicular to the bank, designed to trap bedload sediment and promote riparian vegetation growth. Image dates October 2016 (left, just after project installation), October 2017 (center), and April 2019 (right; higher discharge at this time, inundating the foreground sediment). Note the lack of significant sediment accumulation between the log structures. An additional project constructed September 2017 is visible cross-river in the last two images [Color figure can be viewed at wileyonlinelibrary.com]
