LATERAL-LOAD RESPONSE OF A REINFORCED CONCRETE BRIDGE

By Marc O. Eberhard,¹ Member, ASCE, and M. Lee Marsh,² Associate Member, ASCE

ABSTRACT: Cyclic, transverse loads were applied to the bents of a three-span reinforced concrete bridge. At a load equal to 45% of the bridge's weight, the bent drift ratio was 0.5%. The bridge's high stiffness was attributed to its continuous superstructure and stiff abutments, which resisted approximately 80% of the applied load. After the soil surrounding the abutments had been excavated, the bridge's stiffness was 15% of the initial stiffness. After the researchers had isolated the bridge superstructure from the abutments, the stiffness was 9% of the initial stiffness. Despite the bents' poor details, damage was limited to yielding of the wingwalls and column cracking; similar bridges should resist likely transverse seismic motions with little damage. The tests provided estimates of the abutment and bent resistances that can be used to evaluate modeling procedures. Following existing modeling procedures, the researchers assembled a model that reflected the measured nonlinear properties of the concrete, steel, soil, bearing pads and polystyrene. T

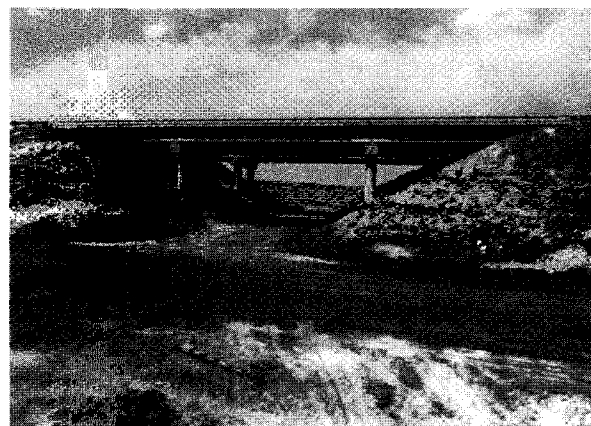
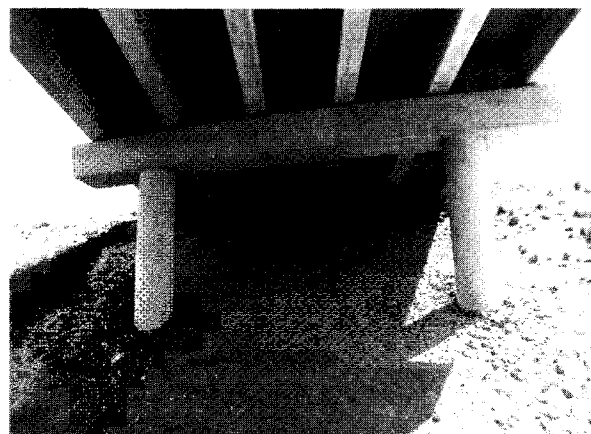
FIG. 1. Bridge South Elevation and West Bent

The bridge that was tested (Fig. 1) was located on Interstate 90 in Washington State. It was one of a pair of reinforced concrete bridges that had been slated for replacement by fill because the bridges spanned an abandoned railroad line.

mainly by a 165-mm thick, reinforced concrete slab, which was continuous over the two bents. The slab was constructed compositely with six, prestressed concrete I-girders (Fig. 1).

This paper discusses the lateral-load response of a three-span reinforced concrete bridge that was constructed in 1966 (Fig. 1). The objectives of the work discussed in this paper were as follows:

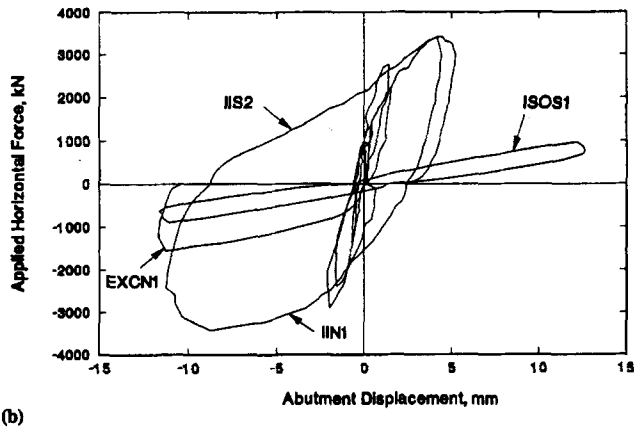
FIG. 6. Measured Response Histories

For each half cycle, Table 1 lists the average abutment and bent displacements measured between the beginning of each half cycle and the time of maximum load. The corresponding displacement response histories are presented in Fig. 6.

Large variations in stiffness are apparent in the response histories (Fig. 6). To quantify the stiffness decreases for each test, effective stiffness (Fig. 9) were computed based on the maximum load and displacement at the points of maximum load (Table 1). The bridge's initial stiffness was 900 kN/mm, but it decreased to 77% of the initial stiffness during two cycles to a drift ratio of 0.05% (test I). The effective stiffness decreased further (to 41% of the initial stiffness) during the cycles in which the wingwalls were damaged (test II). After

Between cycles EXCN1 and ISON1 (Fig. 6 and Table 1), it is unlikely that the bent stiffness changed significantly because the bents had been subjected to similar displacements in test II. Based on a comparison of the response histories in these two cycles, it appears that the bearing pads and polystyrene at the two abutments contributed a force of approximately 600–700 kN before they slipped. Considering that the vertical reaction at each abutment was approximately 800 kN, this slip force corresponded to coefficient of friction for the bearing pad/polystyrene combination of 0.38 to 0.42. After slip the excavated tangential stiffness was the same as the isolated

Large variations in the bridge's energy-dissipation characteristics are apparent in Fig. 6. To quantify these variations, the bent force-displacement response was integrated to obtain the energy dissipated per loading cycle (Fig. 9). Most of the energy was dissipated during test II (1½ cycles at 45 kN·m/cycle) and test EXC (½ cycles at 25 kN·m/cycle).

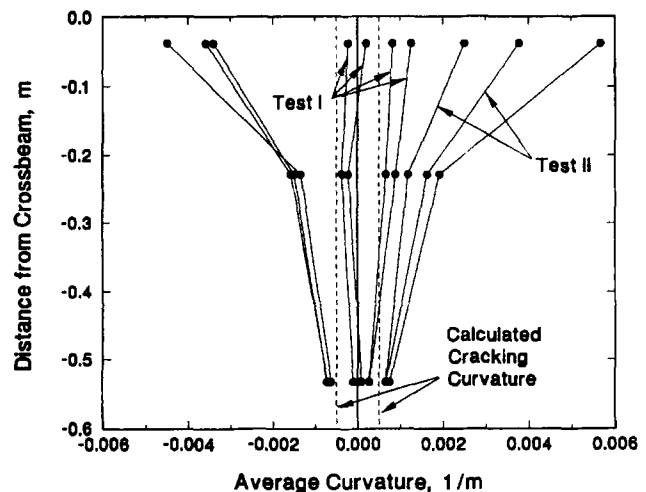
FIG. 7. Curvatures at Maximum Loads for Northwest Column

Fig. 7 reports the average curvatures at the top of the northwest columns for each half cycle at the time of maximum applied load. The curvatures were computed based on relative rotations of adjacent beam section located 0, 75, 380, and 685 mm from the crossbeam soffit. On the basis of the measured strength of concrete cores (44 MPa) and a rupture modulus of $0.6\sqrt{44}$, the cracking curvature was estimated as 5×10^{-5} rad/m. As shown in Fig. 7, the northwest column exceeded the cracking curvature for the first time during test I. The measured curvatures were consistent with the observed cracking.

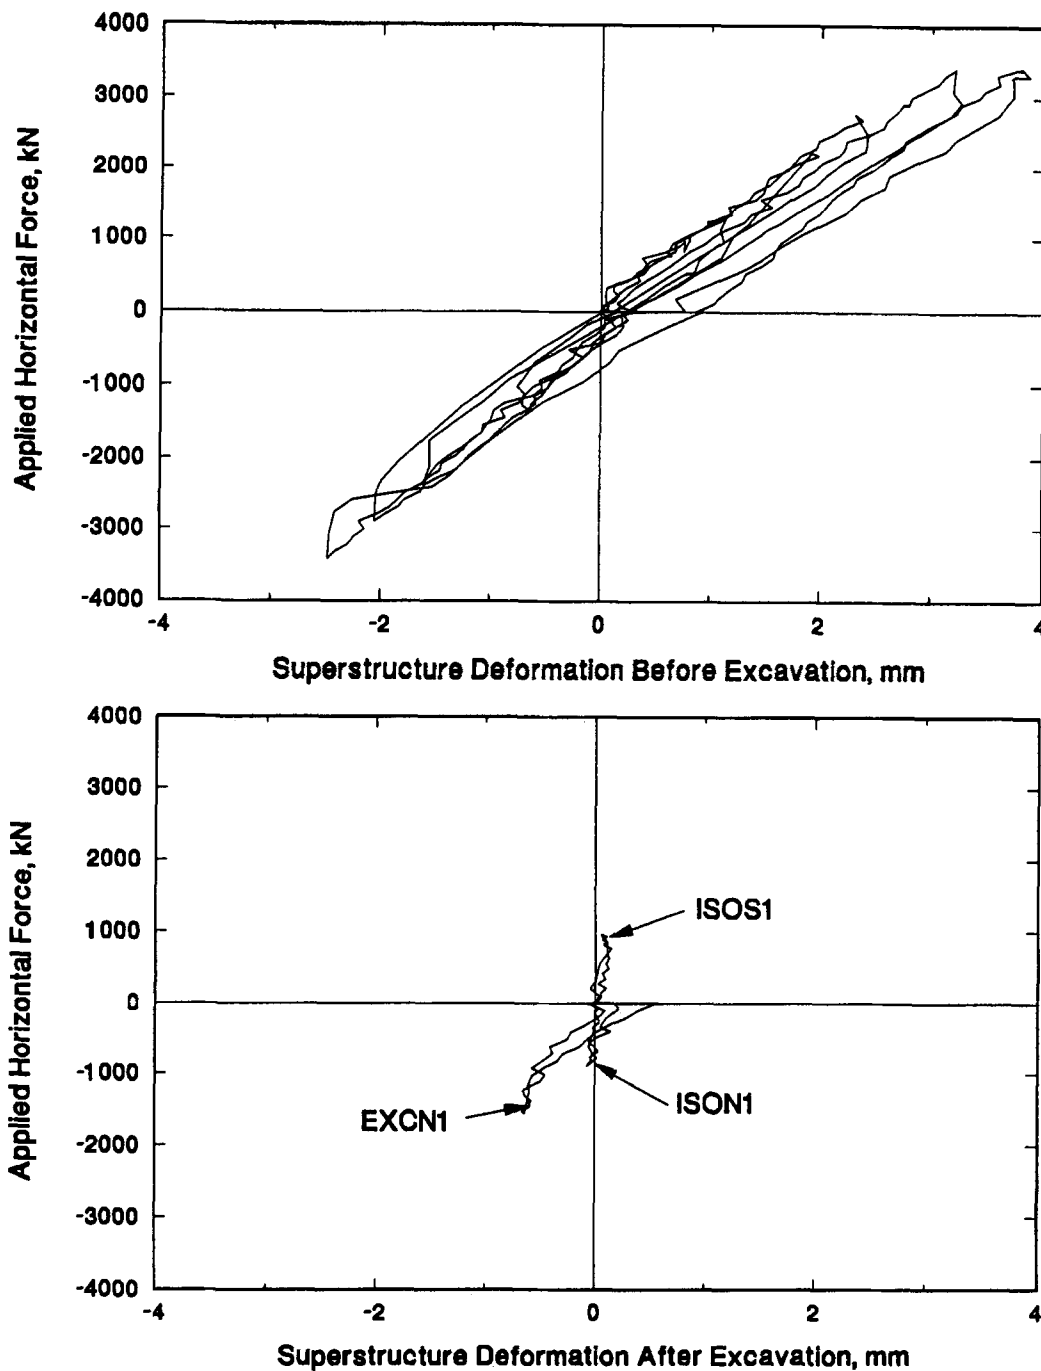
FIG. 8. Superstructure Deformation History

Another opportunity to check for internal consistency was the computed superstructure deformation, which was calculated as the average bent displacement minus the average abutment displacement. As shown in Fig. 8, superstructure deformation varied linearly with the applied load for test P, I, and II. Such a linear relationship is reasonable because the force-deflection relationship for the superstructure likely remained linear, and the transverse superstructure shear was approximately proportional to the applied load. The shear was proportional to the applied load because the bents were relatively flexible and their force-deflection relationships likely remained

nearly linear. As expected, the superstructure deformation after excavation (test EXC) was smaller than in previous tests because the excavation had reduced the abutment resistance. The superstructure deformation was negligible after isolation (test ISO) because the abutment resistance was negligible.

stiffness. This observation was corroborated by the superstructure deformation measurements. During the latter portion of half-cycle EXCN1 (loads exceeding 1,000 kN), the slope of the applied force-superstructure deformation curve was similar to the slope of the corresponding ISO curve (Fig. 8).
