# Northridge Earthquake

California

January 17<sup>th</sup> 1994 (4:30AM PST)

M 6.7

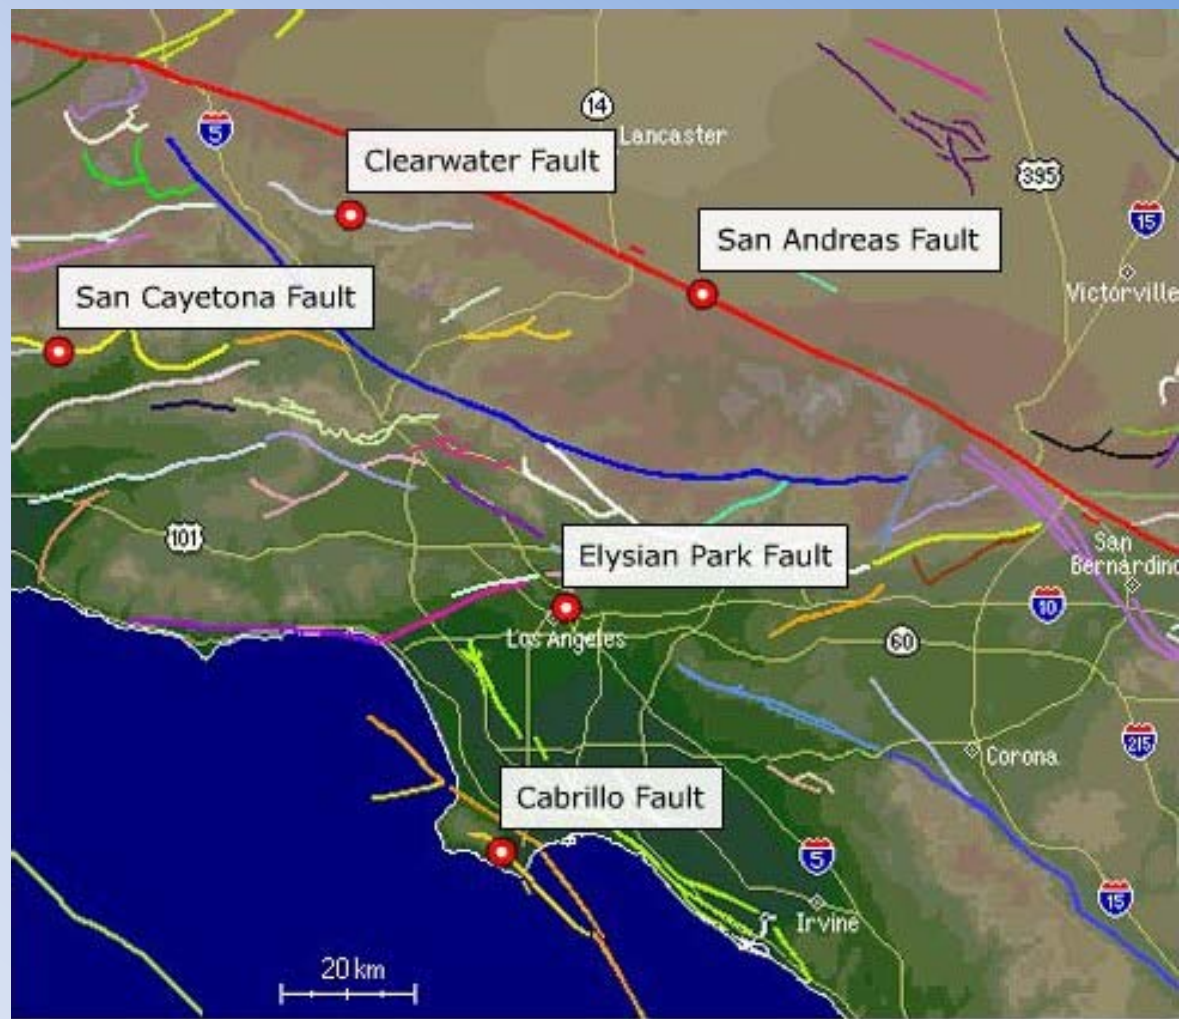
# Southern California Fault Lines

Fault with historical movement
-

Fault active during Quaternary
-

Fault without recognized Quaternary Movement

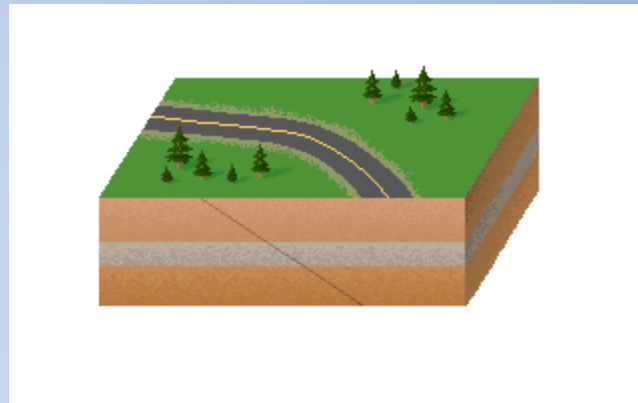
# Thrust Fault

A thrust fault, also called a reverse fault, is one in which the upper side of the fault (the "hanging wall") appears to have been pushed upward and over the adjacent ground (the "footwall"). This is the opposite of a gravity, or normal, fault. A blind thrust fault is a thrust fault that does not rupture all the way up to the surface so there is no evidence of it on the ground. It is "buried" under the uppermost layers of rock in the crust, which may be folded over one another, hiding the fault.

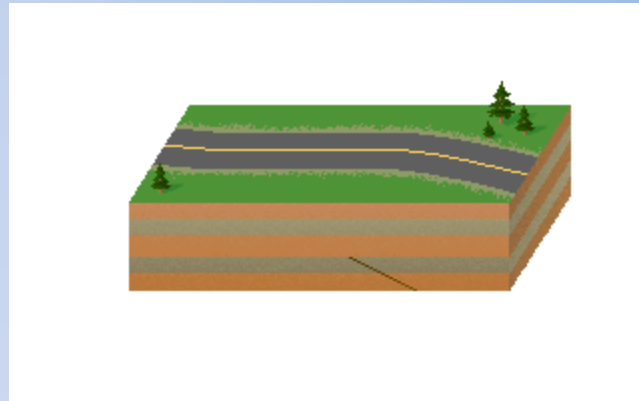
# Blind thrust fault

AKA: buried or concealed fault

- One side moves upward over the other
- The fault doesn't break the ground surface
- Difficult to map
- Several uplifts found, but no evidence of ground rupture

The 1994 Northridge earthquake was caused by a type of fault called a blind thrust fault.

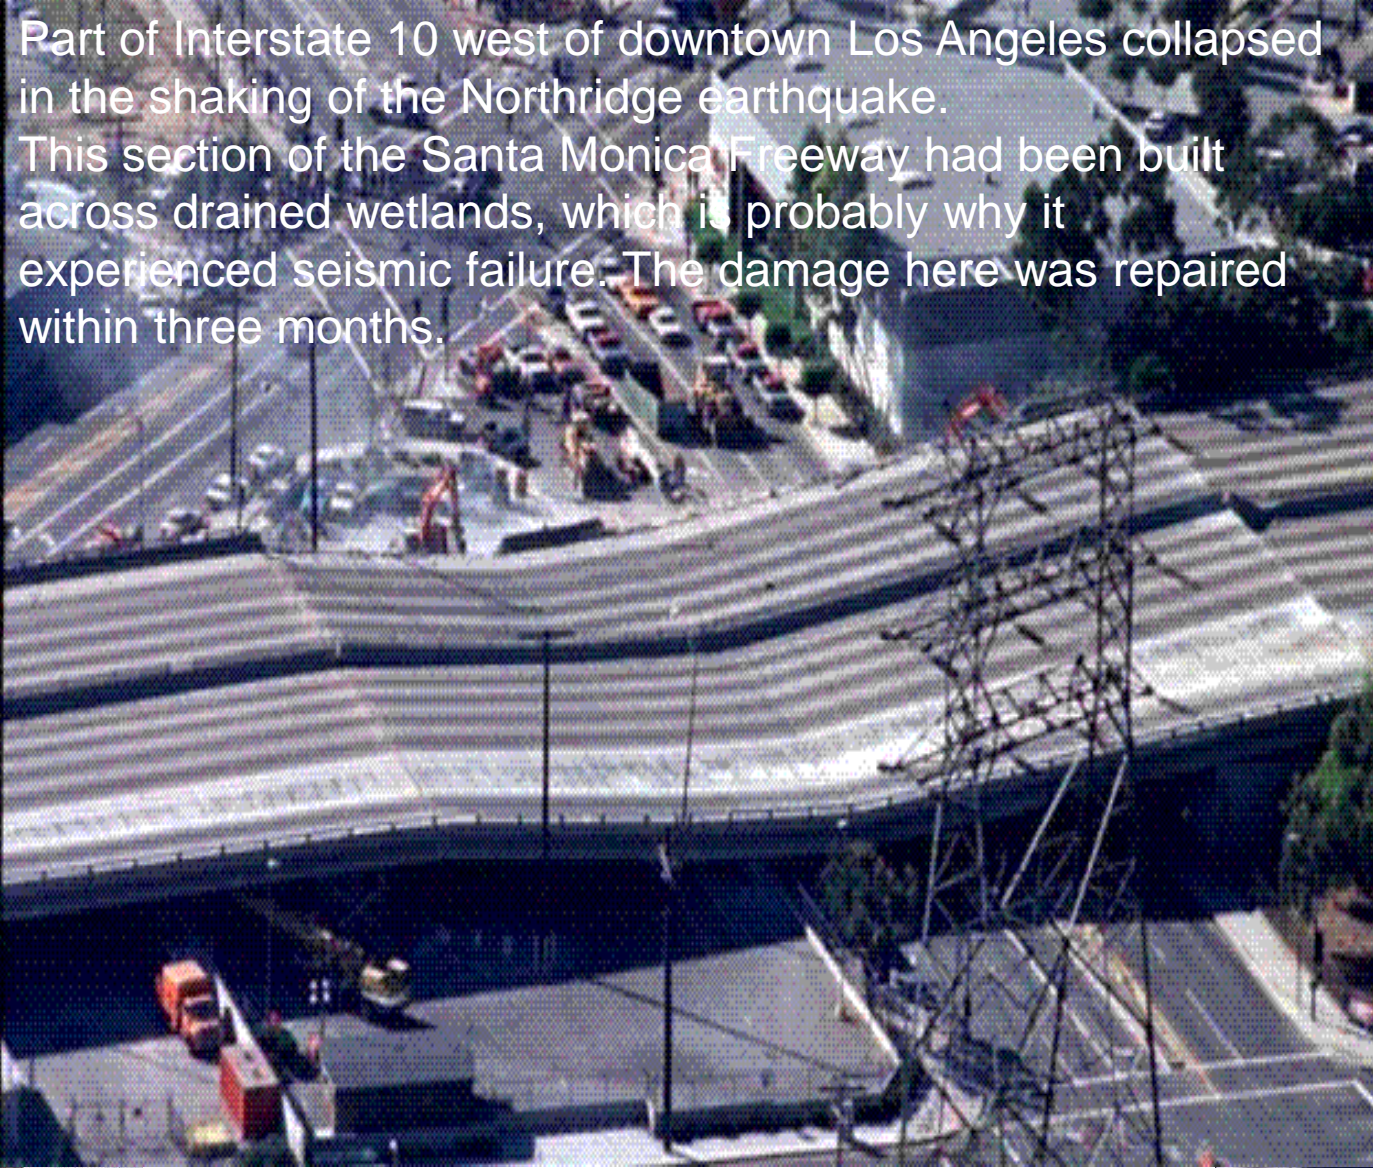
Part of Interstate 10 west of downtown Los Angeles collapsed in the shaking of the Northridge earthquake. This section of the Santa Monica Freeway had been built across drained wetlands, which is probably why it experienced seismic failure. The damage here was repaired within three months.
