**Project:** Muckelshoot Indian Casino Parking Structure, Auburn, Washington

**Subject:** Concrete Parking Garage Condensation and Crack Problems

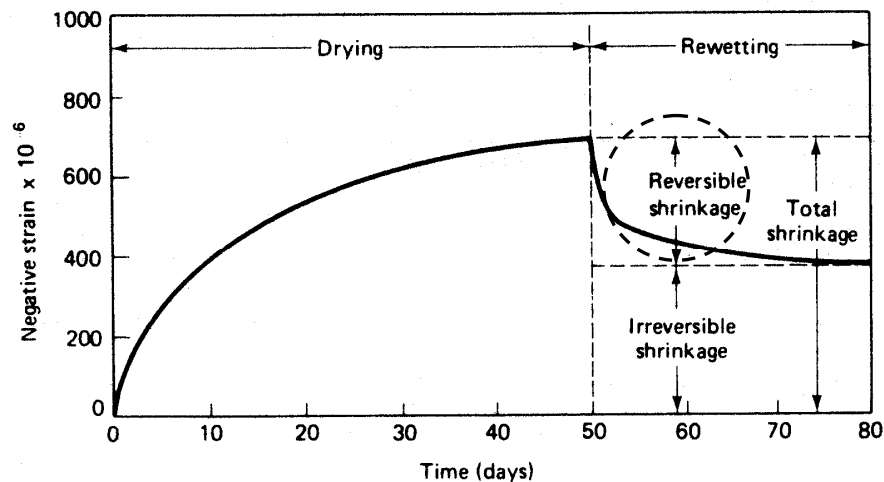
All concrete surfaces at the parking structure are painted. This impervious paint layer acts like an impervious membrane coating the concrete surface<sup>1,2</sup>. Concrete surface can absorb some moisture upon rewetting, or in this case as the vapor changes to liquid. This phenomenon is shown in Figure 1<sup>3</sup>.

**Figure 1:** Reversibility of drying shrinkage

However, when concrete surface is coated with an impervious membrane, i.e., oil-based paint, this absorption cannot take place, and hence condensation occurs. This is probably the most reasonable explanation for what happened on January 19, 2005.

In order to prevent future condensation problems in the future, should favorable atmospheric conditions prevail, additional H.V.A.C. measures should be considered, to ensure proper air circulation throughout the entire parking structure. However, the frequency of such conditions to induced condensation are not such that make such a decision an emergency.

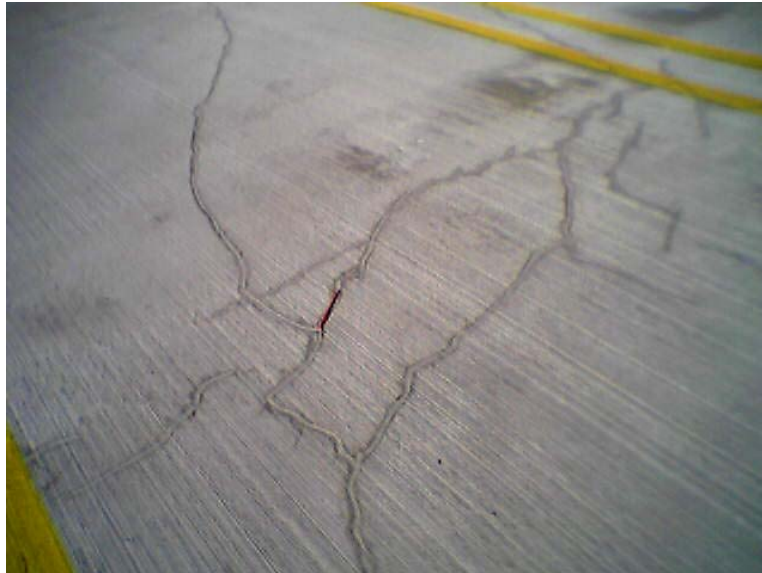
When I inspected the parking structure on Wednesday, February 9, 2005, I noticed unusual amount of visible cracking on the roof of the parking structure as shown in Figure 2.

**Figure 2:** Cracks on the top floor of the parking structure

It appears that these cracks were generated as the result of improper curing or no curing at all, when the concrete was placed. It also appears that instead of repairing the cracks structurally, only water sealant or caulk were applied to the cracked areas. While water

sealants prevent moisture and debris from getting into the cracks, it does not help the structure compensate from the lack of continuity in the material itself. This may lead to improper load transfer and cause undesirable stress concentration in other parts of the structure.

In conclusion, the presence of such major cracks in a concrete slab is not structurally acceptable, and in extreme cases the structural integrity of the concrete may be seriously affected. Application of the water sealant that is in place now, is not a structural solution and all it does is to prevent water and deleterious substances from getting into the cracks. In order to ensure proper load transfer within the slab, a structural repair, such as epoxy injection, is recommended.

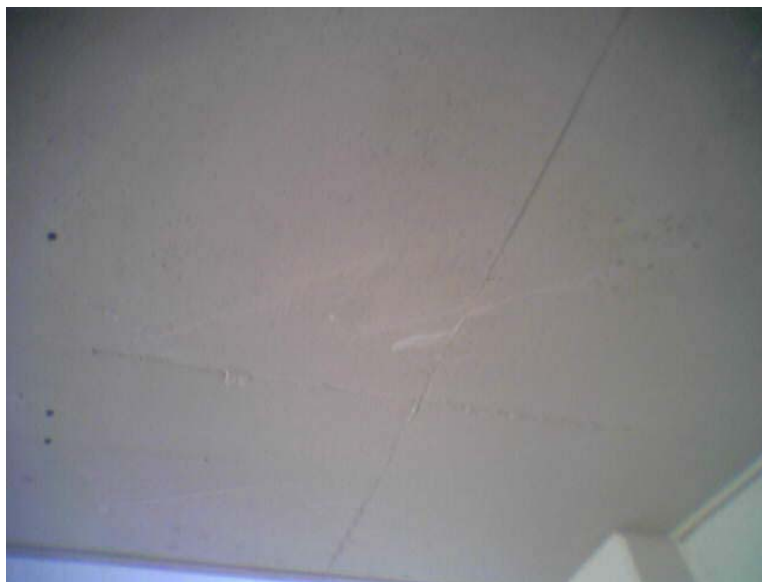
Looking on the bottom of the same slab, cracks revealed themselves at almost the same location on the opposite side of the slab (Figure 3), suggesting that they might be through cracks.

**Figure 3:** Cracks on the bottom of the same slab

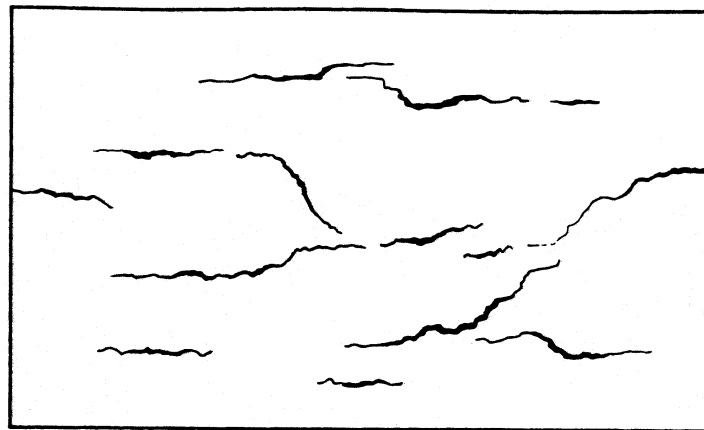
Figure 4 shows typical plastic shrinkage cracking in concrete<sup>4</sup>.

**Figure 4:** Typical plastic shrinkage cracking

For the first few hours, concrete is plastic and has little strength. Water can move relatively freely in what is still a mixture of cement, aggregate, and water. The least dense components of the mixture, air and water, tend to move upwards towards the top surface as the heavier materials move down due to gravity during compaction. The upward movement of water is known as “bleeding” and water that reaches the surface evaporates. The evaporation is more rapid at high temperatures and/or low humidity, particularly in windy conditions. If water evaporates from the surface faster than it bleeds, there is a net loss of water from the surface of concrete, leading to a net reduction in volume. The surface of concrete tries to shrink, but is restrained by underlying layers which have not lost moisture to the same extent. The result of the restraint is that tensile stresses develop in the surface. As the concrete is still in the plastic state and has very

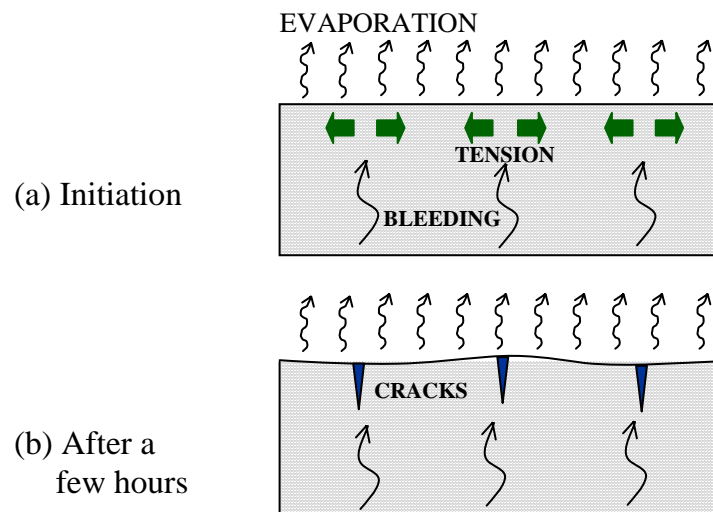
low strength, irregular cracks develop. The process is illustrated in Figure 5, the upper part showing initiation and the lower the condition after a few hours.

**Figure 5:** Formation of plastic shrinkage cracks

The only certain way to avoid plastic shrinkage cracks is to reduce the rate of evaporation from the surface of fresh concrete by early curing.
